Cuyahoga County Urban Mold & Moisture Project

Housing Remediation

Jim LaRue
Environmental Health Watch
www.ehw.org

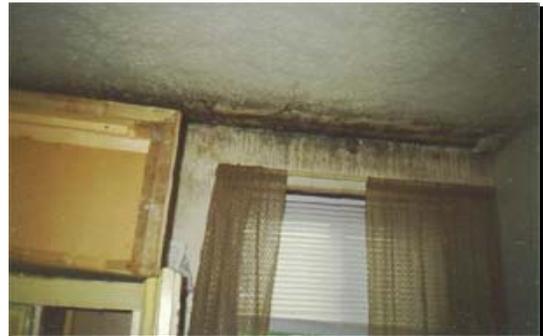
- 🏠 Post-WWII bungalows and ranch homes on slab:
 - Leaking sub-slab heating ducts
 - Water vapor from ducts condenses on cold exterior walls causing mold growth

Mold generated by moisture from sub-slab heating ducts

Spec: Install updraft furnace with new duct system and fill old ducts with cement

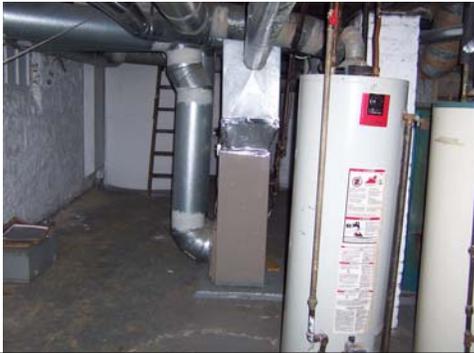
- 🏠 Cold air return not connected to forced air furnace
- 🏠 Furnace pulls air from across basement floor
- 🏠 Spec: Duct cold air return directly to furnace

- Done a third of the houses; avg. cost = \$553; max \$1600
- Some contractors "panned" the floor joists with sheet metal instead of installing full duct

Repair of "Cleveland drop" by ducting cold air return directly to furnace

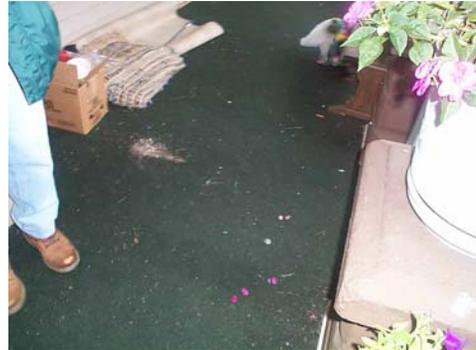
Foundations extend under porch, allowing water to enter basement when porch flooring deteriorates
-

- Avg. cost = \$312
- Covers the lead paint on deck
- Does the lead dust in the carpet get tracked into the house or is it trapped?

Indoor/outdoor carpeting on porch

Spec: Two layers of 6 mil plastic on old deck, sealed at perimeter. Indoor/outdoor carpet installed

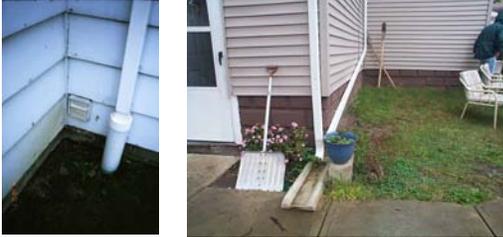
With deterioration, water leaks and spills at foundation walls
-

- Downspout disconnect avg. cost = \$114
- Gutters resploped avg. cost = \$145
- Sometimes water flow not adequately diverted from foundation

Downspout disconnected

Spec: Downspouts disconnected and 5' elbows installed
-

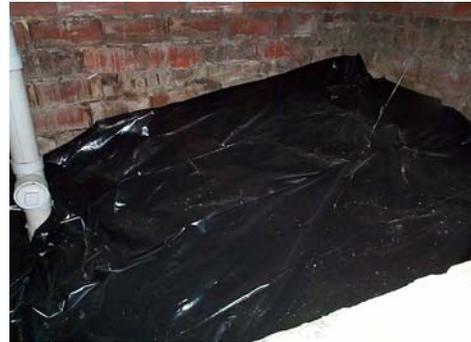
- 🏠 Moisture from dirt floors enters living space
- 🏠 Spec: Remove debris
- 🏠 Spec: Cover floor with 6 mil plastic carried along walls to grade level

- 🏠 Spec execution:
 - Plastic sheeting avg. cost = \$270
 - Debris removal avg. cost = \$305
 - Would have been good to spec "rat slab" at the same time
 - Some crawl spaces missed

Plastic covering crawl space dirt floor
