Cuyahoga County Urban Mold & Moisture Project

Housing Remediation

Environmental Health Watch
and
HouseMender, Inc.

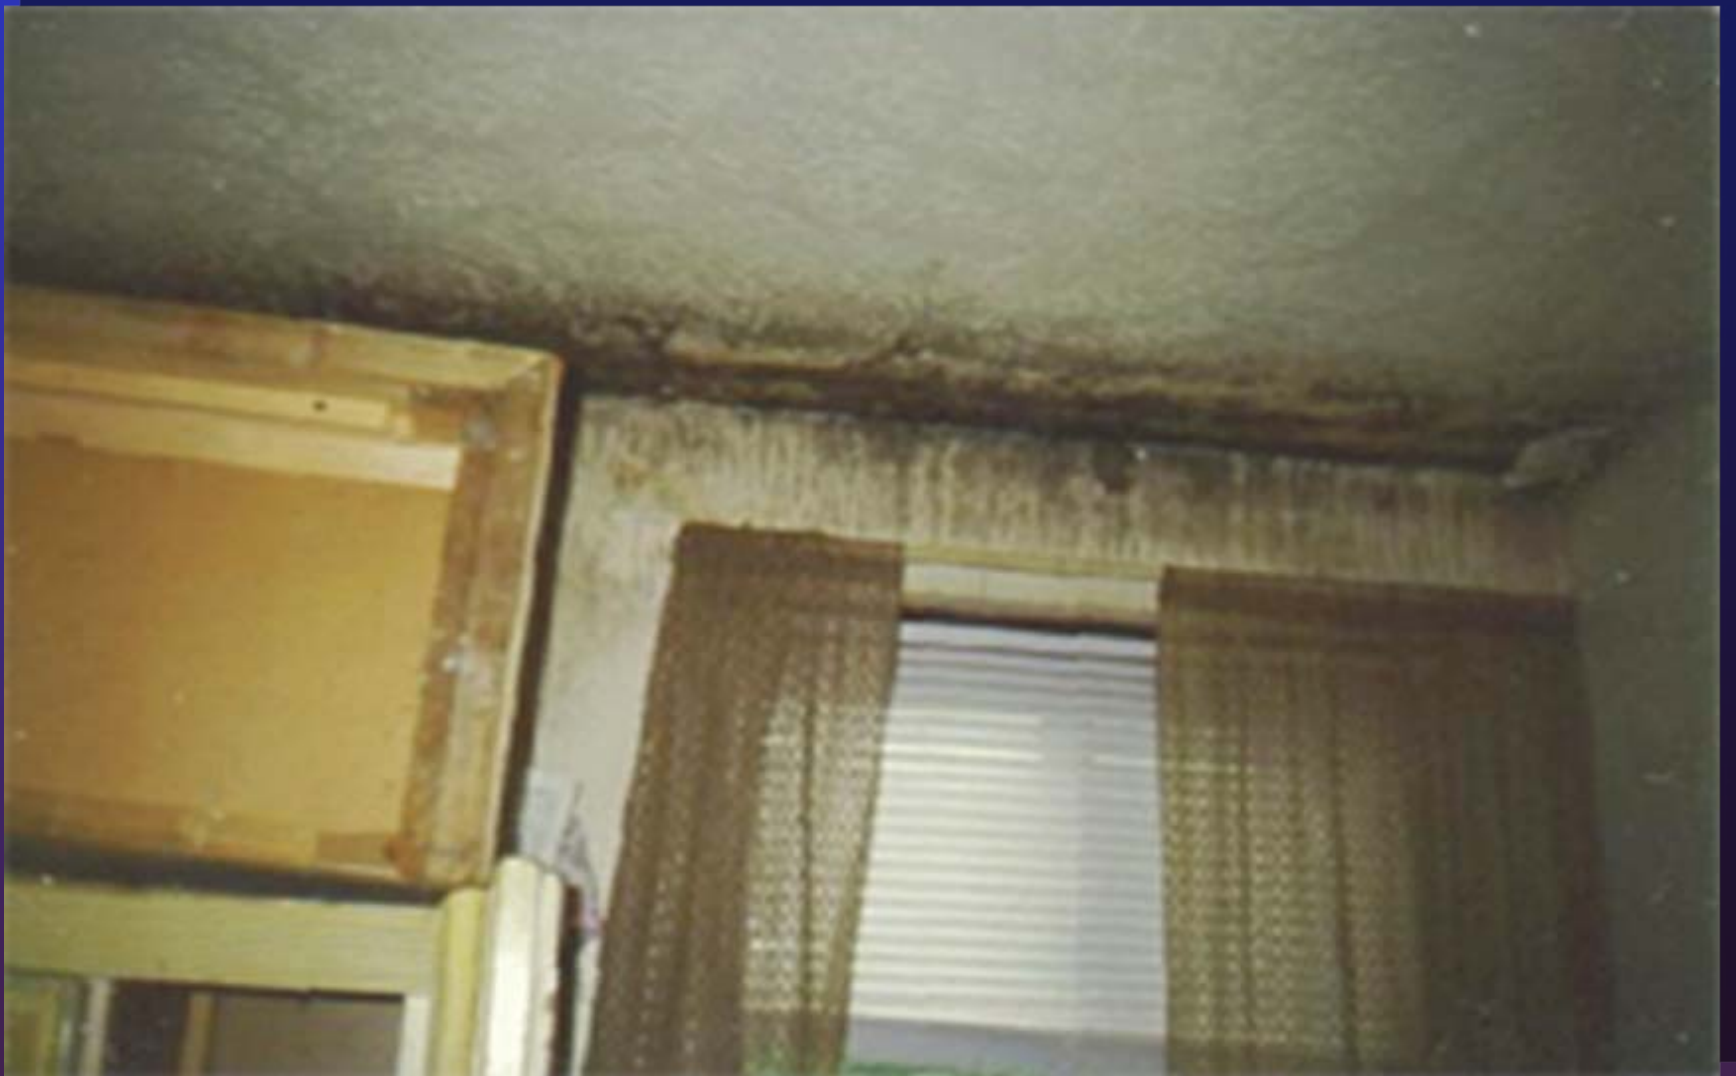
- Leaking sub-slab heating ducts
- Water vapor from ducts condenses on cold exterior walls causing mold growth

Mold generated by moisture from sub-slab heating ducts

Spec: Install updraft furnace with new duct system and fill old ducts with cement

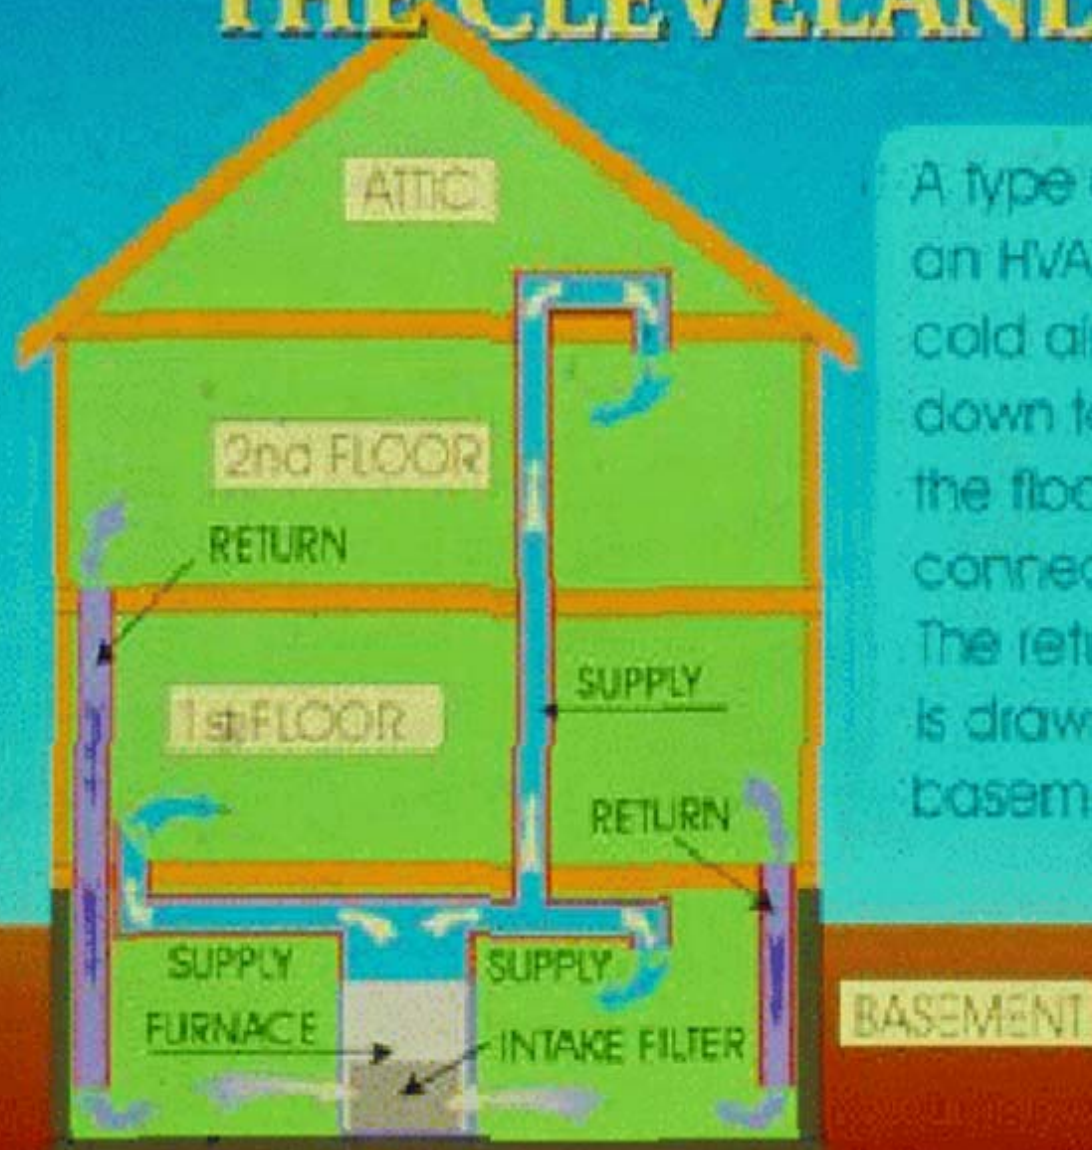
THE CLEVELAND DROP

Cold air return not connected to forced air furnace

Furnace pulls air from across basement floor

A type of configuration for an HVAC system where the cold air return ducts drop down to the basement near the furnace, and are not connected to the furnace. The return air for the furnace is drawn directly from the basement via the filter intake.

Spec: Duct cold air return directly to furnace

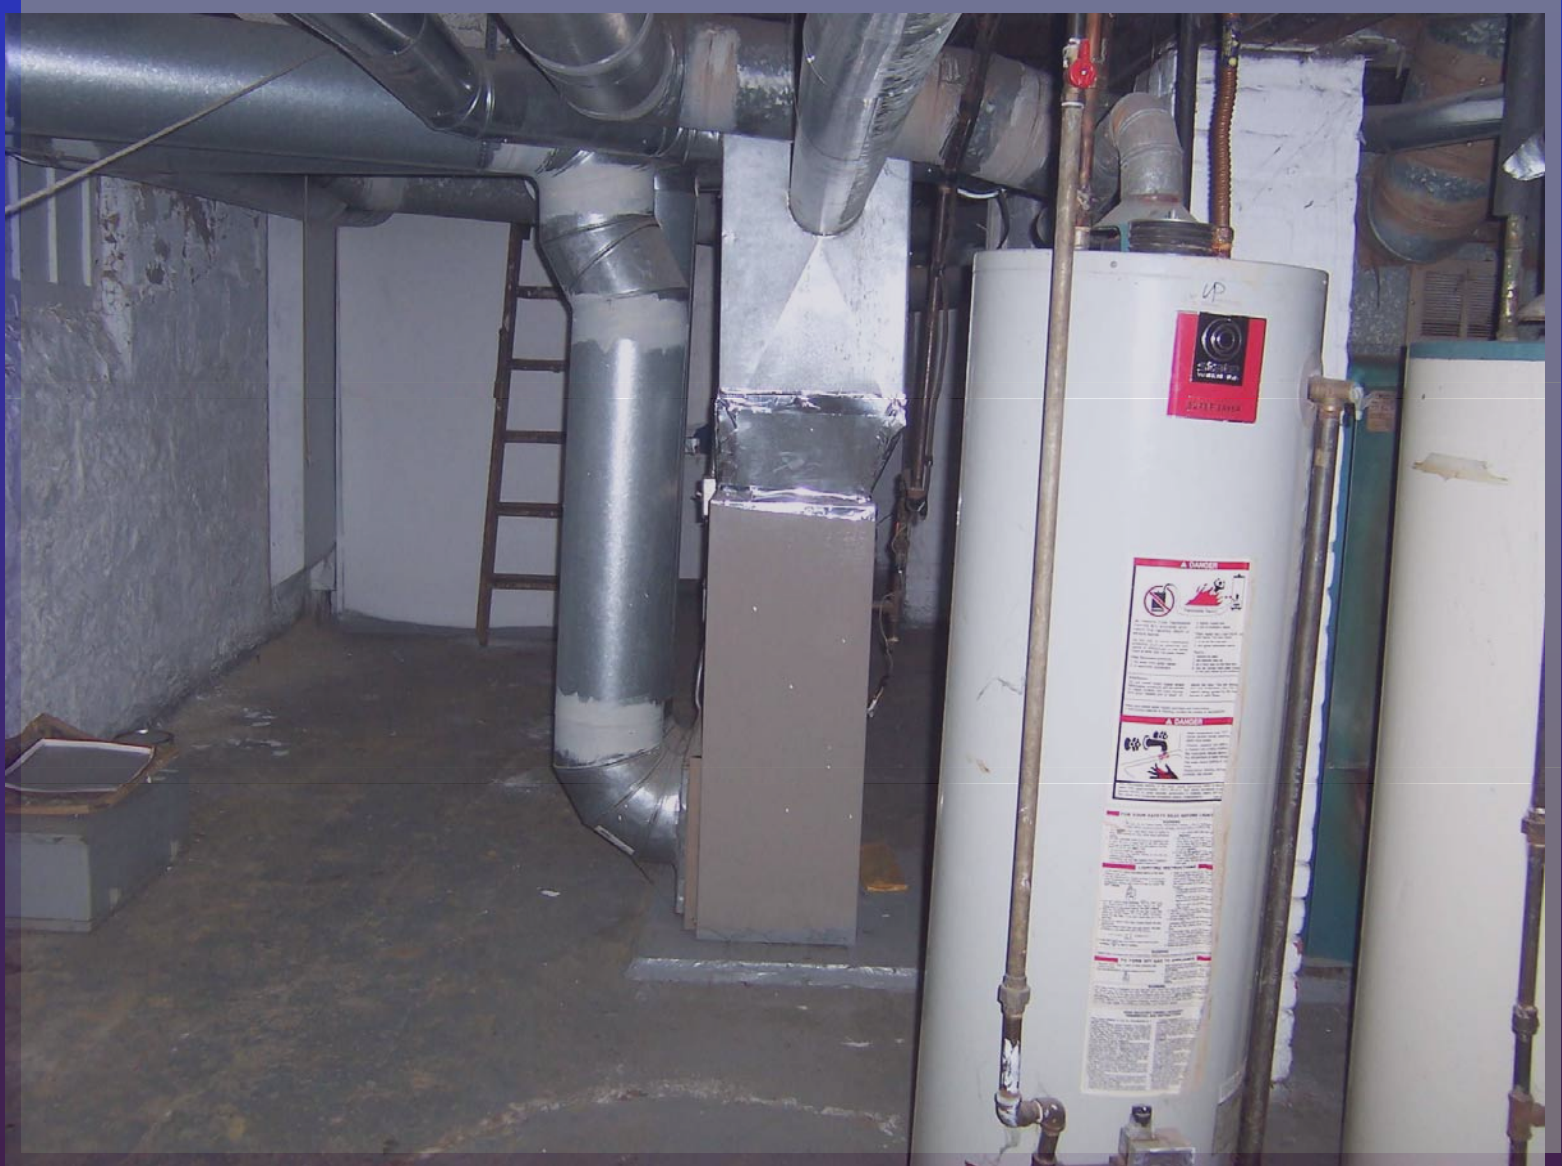
- Done on a third of the houses; avg. cost = \$553; max \$1600
- Some contractors "panned" the floor joists with sheet metal instead of installing full duct

Repair of "Cleveland drop" by ducting cold air return directly to furnace

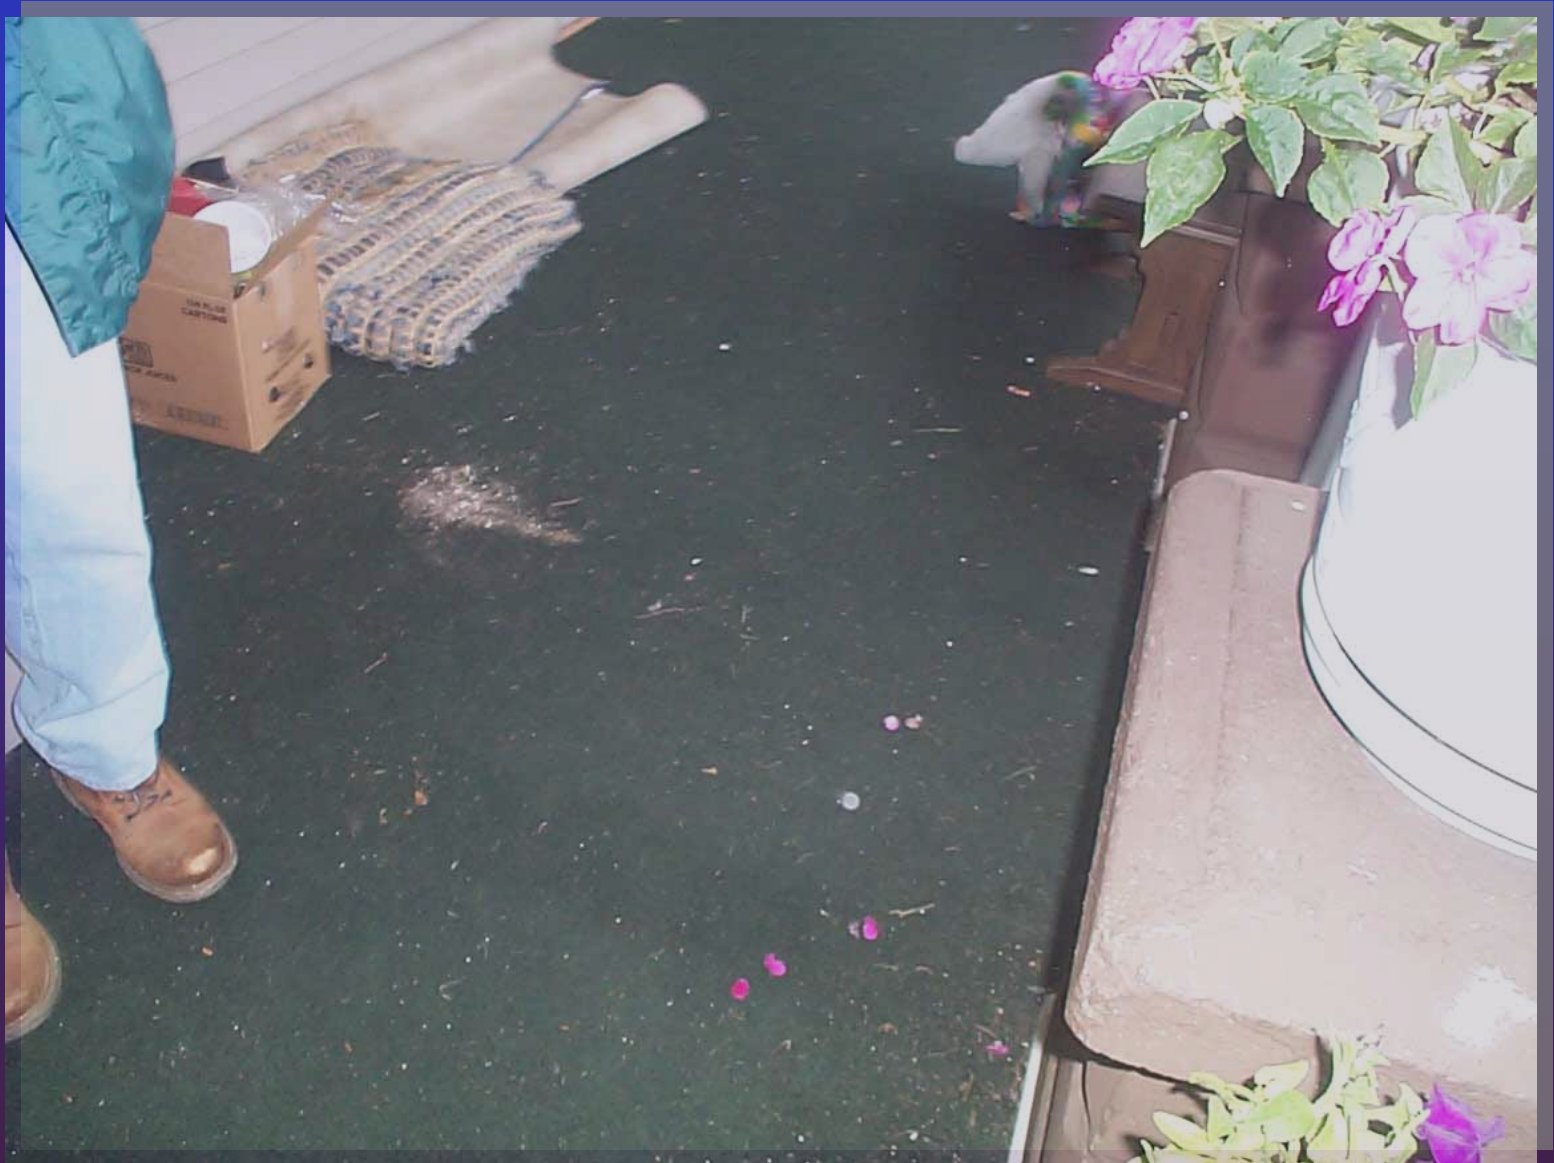
Foundations extend under porch, allowing water to enter basement when porch flooring deteriorates

- Avg. cost = \$312
- Covers the lead paint on deck
- Does the lead dust in the carpet get tracked into the house or is it trapped?

Indoor/outdoor carpeting on porch

Spec: Two layers of 6 mil plastic on old deck, sealed at perimeter. Indoor/outdoor carpet installed

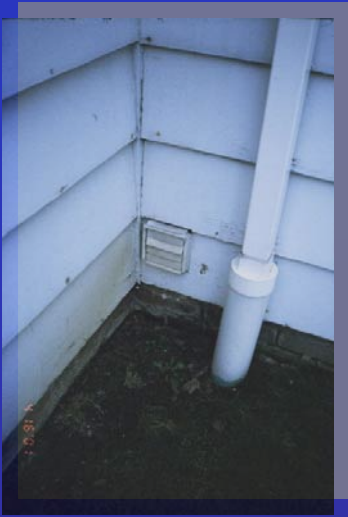
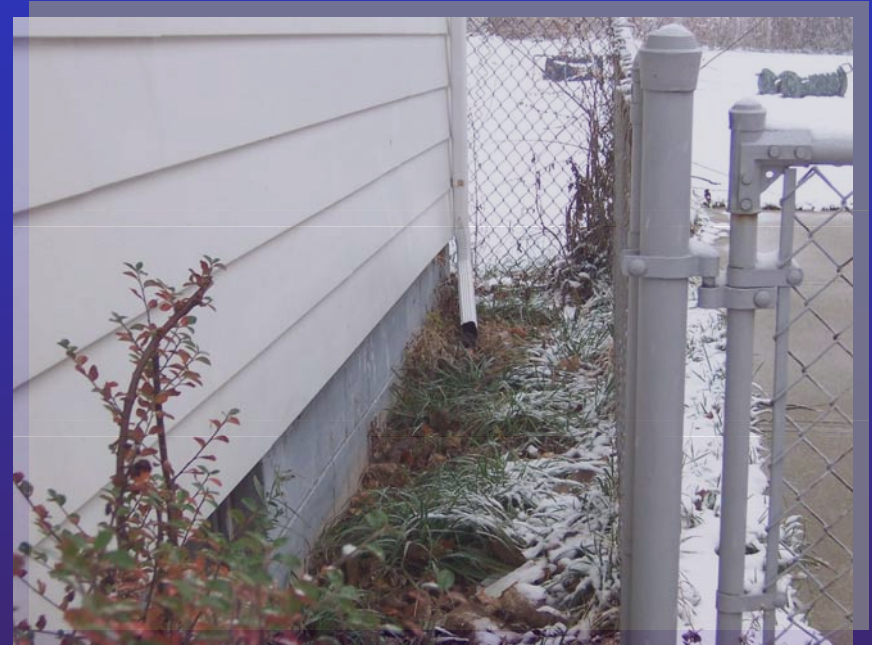
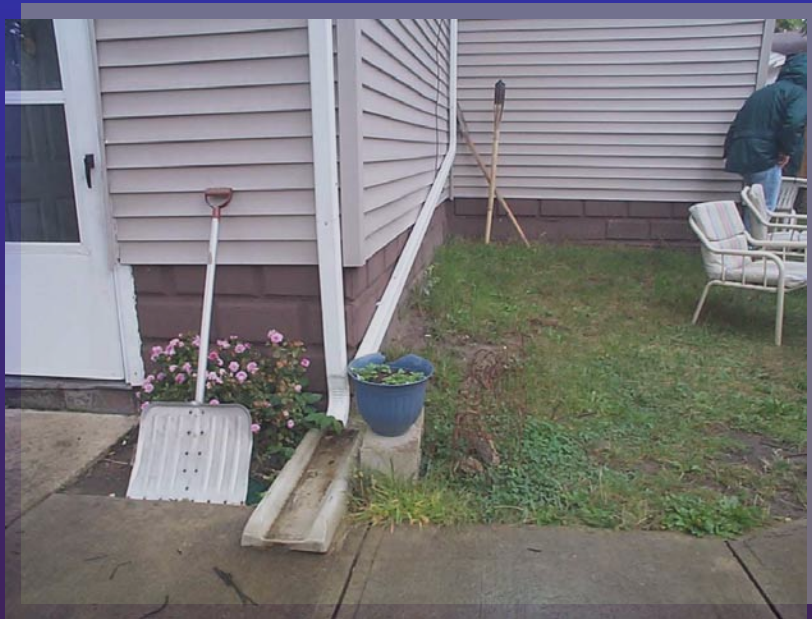
With deterioration, water leaks and spills at foundation walls

- Downspout disconnect avg. cost = \$114
- Gutters repitched avg. cost = \$145
- Sometimes water flow not adequately diverted from foundation

Spec: Downspouts disconnected and 5' elbows installed

Spec: Gutters resloped toward downspout closest to street

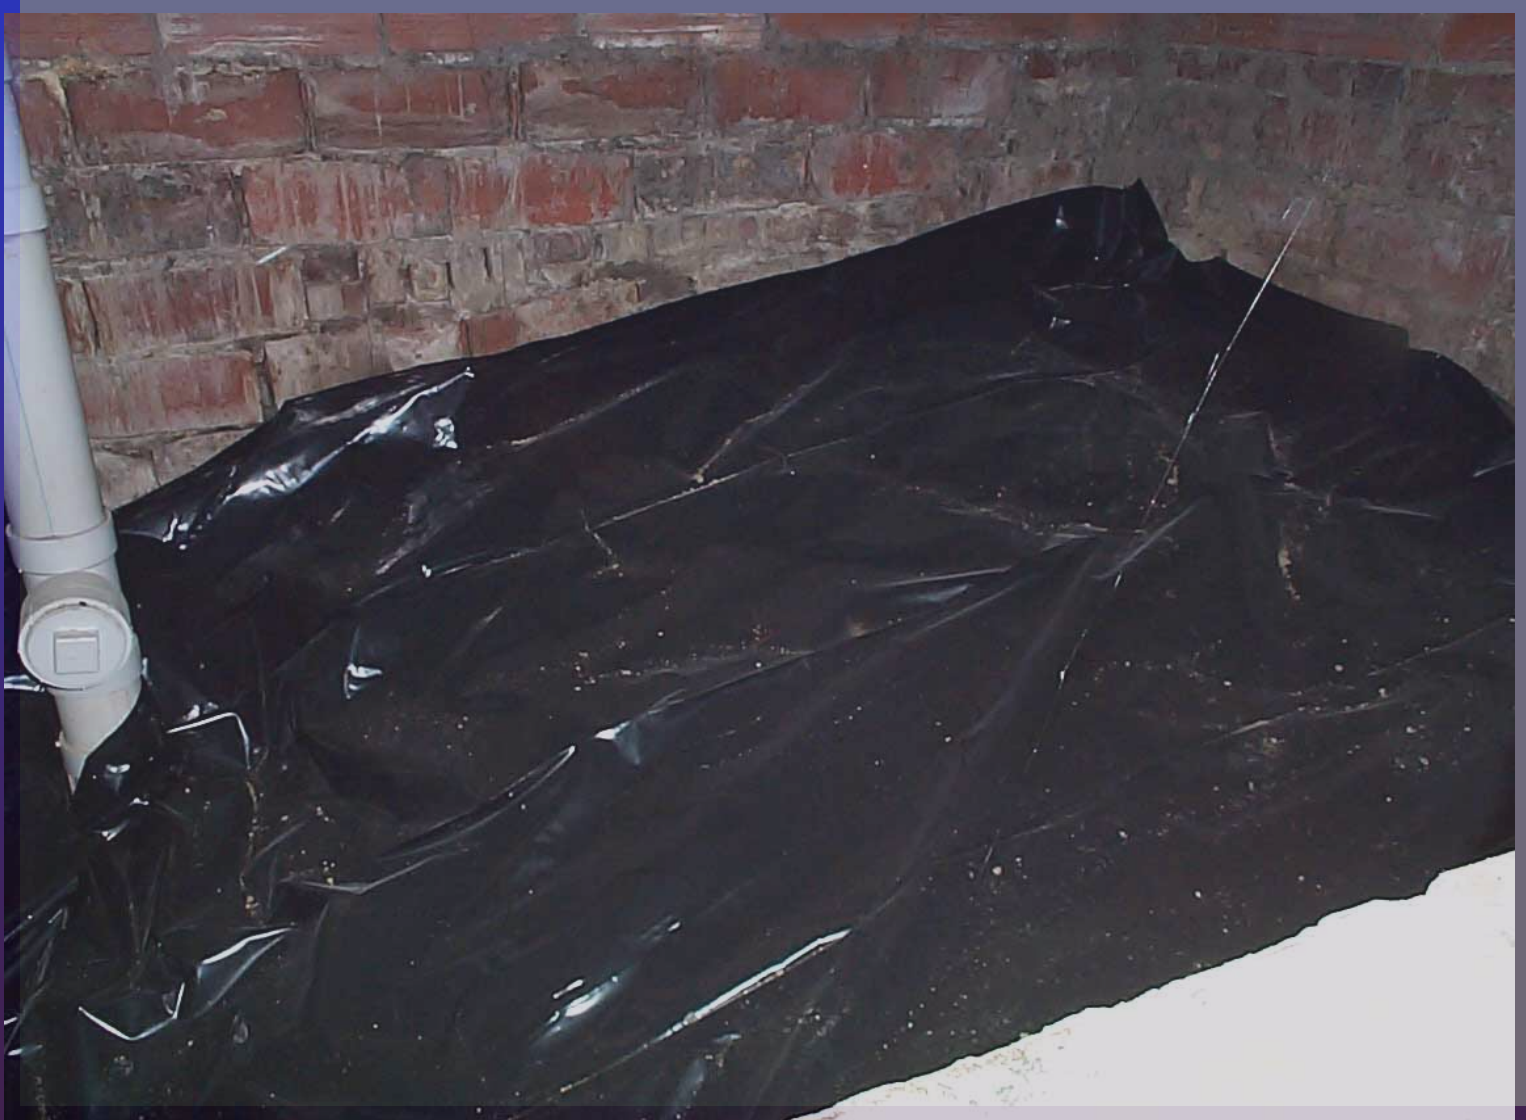
Moisture from dirt floors enters living space

- Plastic sheeting avg. cost = \$270
- Debris removal avg. cost = \$305
- Would have been good to spec "rat slab" at the same time
- Some crawl spaces missed

Plastic covering crawl space dirt floor

Spec: Cover floor with 6 mil plastic carried along walls to grade level
