## Cleveland-Cuyahoga County Healthy House Initiative

# Moisture Control Treatments in Older Housing

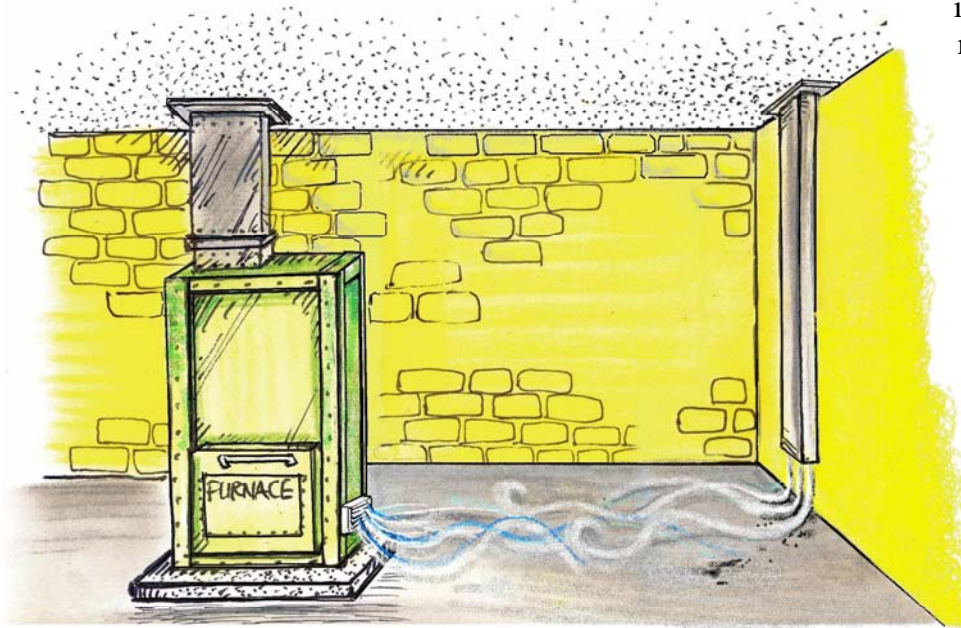
**Problem:** All forced air furnaces need a way to get heat to the rooms of the house and a way to have used air which is now colder return to the furnace to be reheated. In thousands of older Cleveland homes, there is ductwork

carrying heat from the furnace, but the cold air returns are large metal rectangular ducts that go directly from each floor to the basement and are not connected to the furnace. When these furnaces are operating they pull air from all over the basement including these cold air returns we started calling “Cleveland Drops.” Since many of the basements in homes we investigated had significant mold growth on all manner of materials, these furnaces would suck mold spores directly into the heat delivery ducts which would then carry it into the rooms of the house including the bedrooms of the children.

**General Approach:** Connect the “Cleveland Drops” directly to the furnaces to eliminate this pathway for mold spores being transported into the living spaces.

**Treatment:** Remove the “Cleveland Drops” and connect an appropriately sized duct to the cold air return register in the floor or wall of the living space and run that duct to the cold air return opening (where the filter is located).

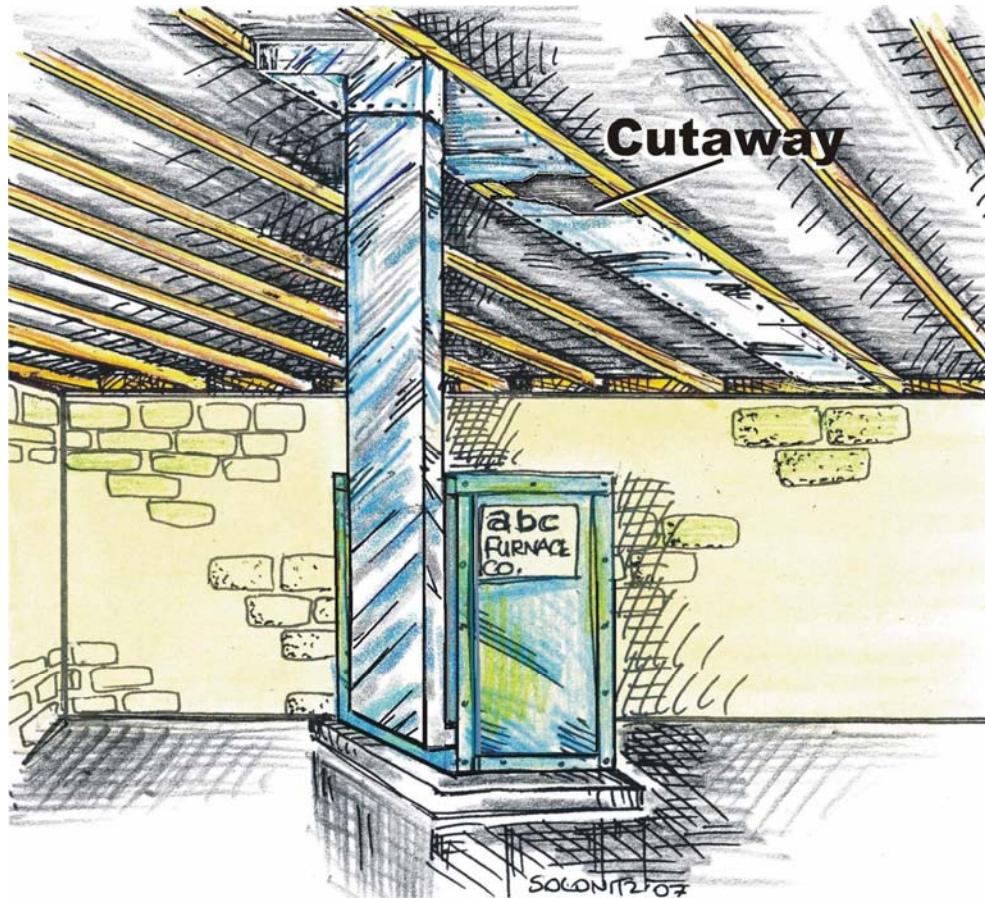
1. Sometimes when the Cleveland Drop is corrected, contractors use the space between the floor joists to carry the air toward the furnace. This is called “panning” the joists, affixing sheet metal across two joists to create an enclosed air space by sealing the sheet metal to the joists with caulk. There are two

problems with doing this: a) the joist cavity itself can be very dirty and/or moldy and b) if there is excess moisture in the house, it can be pulled into the joist cavity where it can contribute to mold growth. Similar practices should be discouraged in any forced-air installation.

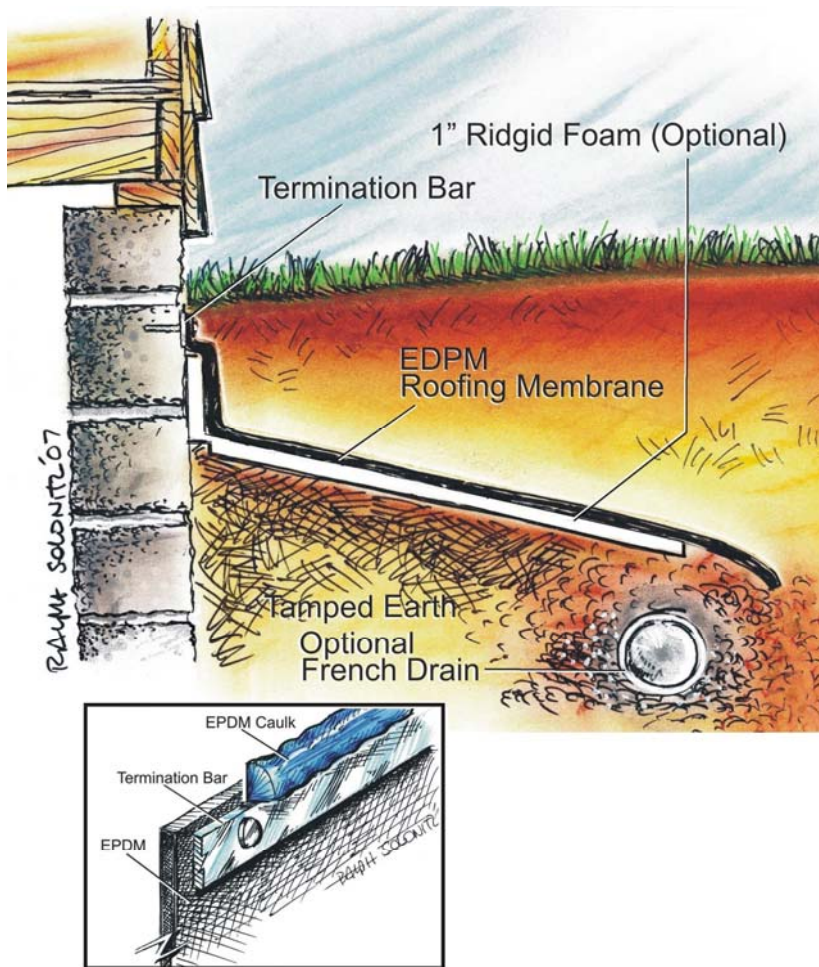
**Treatment:** We would dig a shallow trench about 12” deep and 3’ wide along the foundation wall and slope the trench away from the house slightly. We would then install EPDM rubber roofing material against the foundation wall using a metal fastening bar that was secured into the cinder block or sandstone mortar joints with Tapcon screws. The fasteners can go directly into the cinder blocks. Then the EPDM was spread on to the flat surface of the trench. A caulk designed for use with EPDM was applied along the top edge to stop rain water penetration and then the excavation was backfilled with the soils removed.

1. The top edge of the EPDM and metal flashing needs to be just above the soil level, so chances of water entering that edge are reduced.
2. Because downspout locations are often where worst surface water issues can occur due to overflow of clogged gutters/downspouts and often drop at a foundation corner, wrapping the EPDM around a corner for a couple of feet can help keep this type water problem from penetrating around a corner.

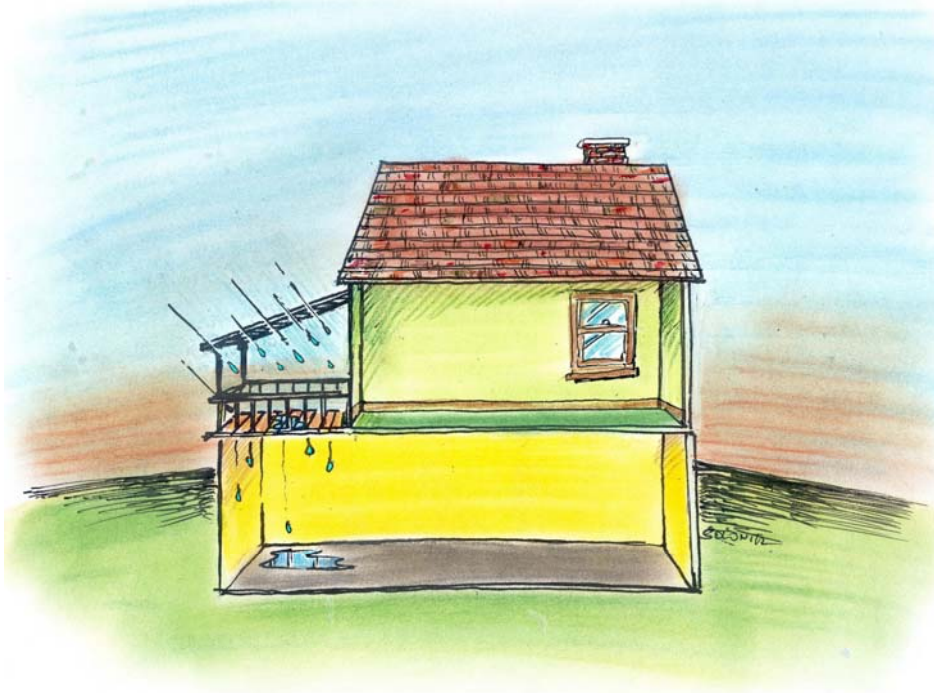
**Problem:** In Cleveland there are hundreds of homes which have the

foundation extending out under the front porch. Over time damage to the porch flooring leads to rain water and snow melt dripping into the basement resulting in moisture issues in the living space under the porch. It is not uncommon to find mold growing on the floor joists under this porch flooring and on all manner of materials stored there.

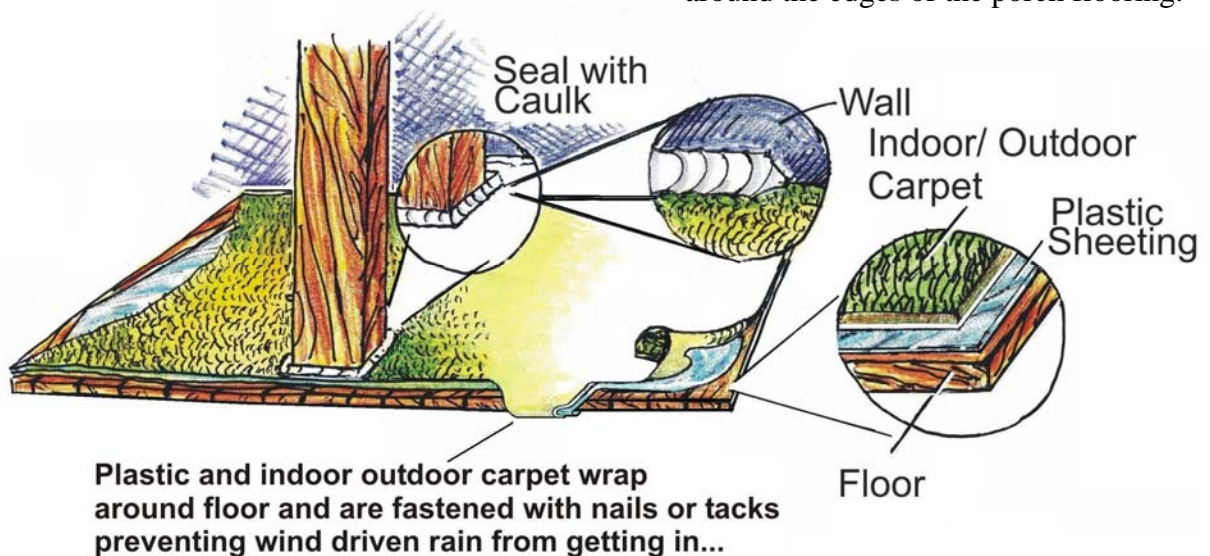
Our low-cost treatment was to install two layers of 6 mil plastic over the existing flooring, making sure it was effectively fastened and sealed against the house wall and any support posts that were set on the porch surface. We would then install indoor/outdoor carpeting on top of the plastic material, securing this flooring as it wrapped around the edges of the porch flooring.

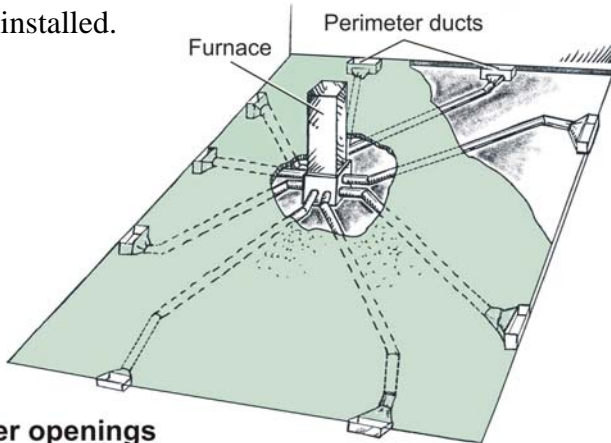
New updraft furnace with new duct trunk line.

**Treatment:** Cement is poured into each hole in the concrete slab where a duct has been and it is leveled with the concrete floor surface. A new updraft furnace is installed where the old furnace was located. A new duct trunk line is installed along the ceiling of the first floor and ducts to each room are run from this main run, including to the second floor. A drop ceiling is then put in place to hide this ductwork.

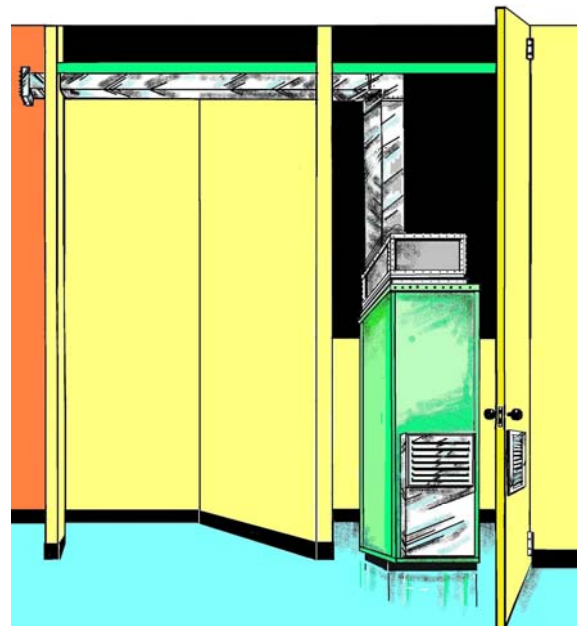
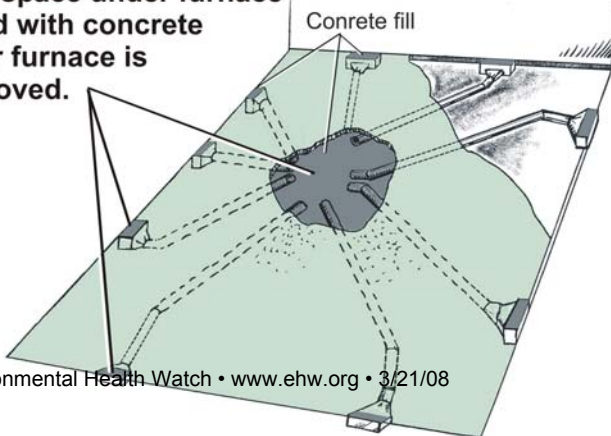
**Register openings and space under furnace filled with concrete after furnace is removed.**

1. It is important to put cement in the old openings or mold spores and moisture vapor from the old ductwork can continue to enter the living space.
2. To avoid having to replace carpeting or patch other flooring after closing off the old system, the heat register covers can be put back on top of the closed off ductwork, so it still looks like it belongs there and fills the space in the flooring.

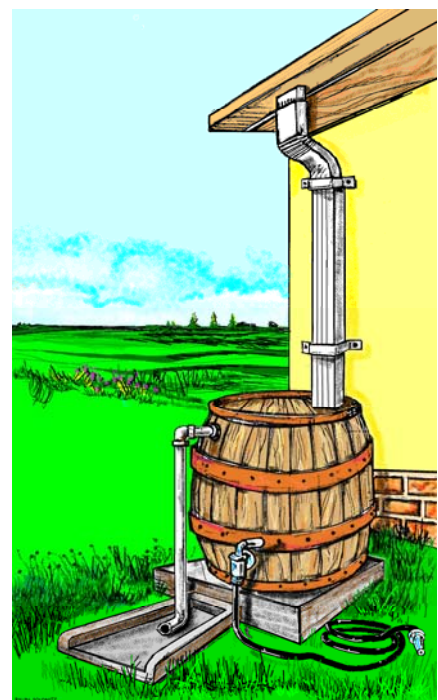
The installation of hooded gutters that keep debris out of them would be very helpful in most of the homes we treat, but at nearly \$10 a foot installed, it is simply too expensive for our programs. The result is that gutters/downspouts are our most troublesome task and where, over time, we are the least successful. On return visits to sites, it is not uncommon to find the extensions we have installed either removed altogether or not facing properly.

3. We make sure that the gutters are properly pitched so water flows effectively.
4. If the underground storm drains seem ineffective, we remove downspouts from these drains and install extensions and/or splash-blocks that carry water at least 5' from the foundation of this house or a neighbor's house. Rain barrels for garden watering can also be incorporated.

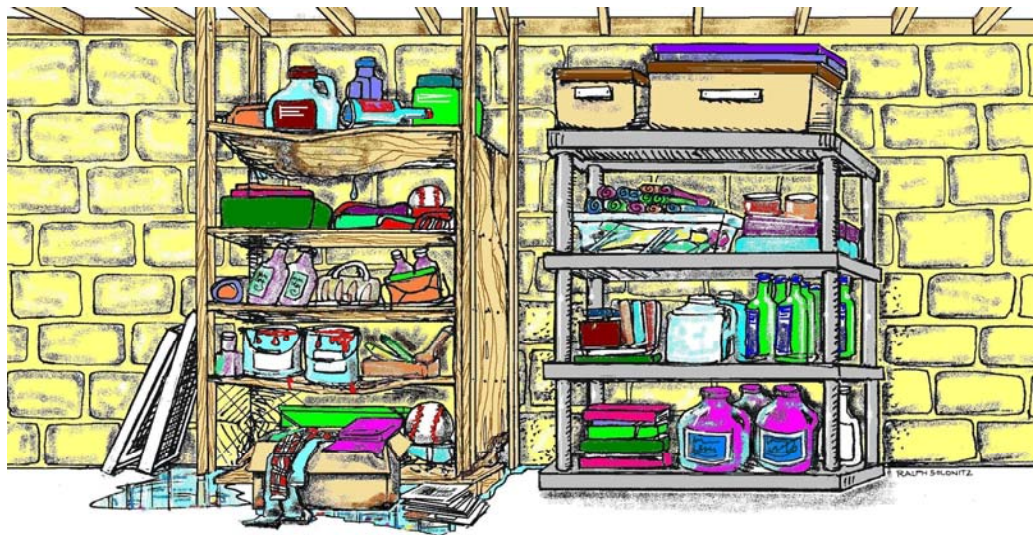
shelving kits that include up to five shelves that are as much as 16” deep and 4’ wide. In addition, this shelving has holes in each shelf that allows air to flow through thus reducing the chance of mold growth in anything on the shelving.

**Potential Problems and Solutions:** There is usually no problem with this shelving itself, but getting residents to use it regularly and effectively can be a challenge. It is not uncommon on our return visits to these sites to find boxes and paper on the damp floors where mold can grow and there is nothing on the shelves.

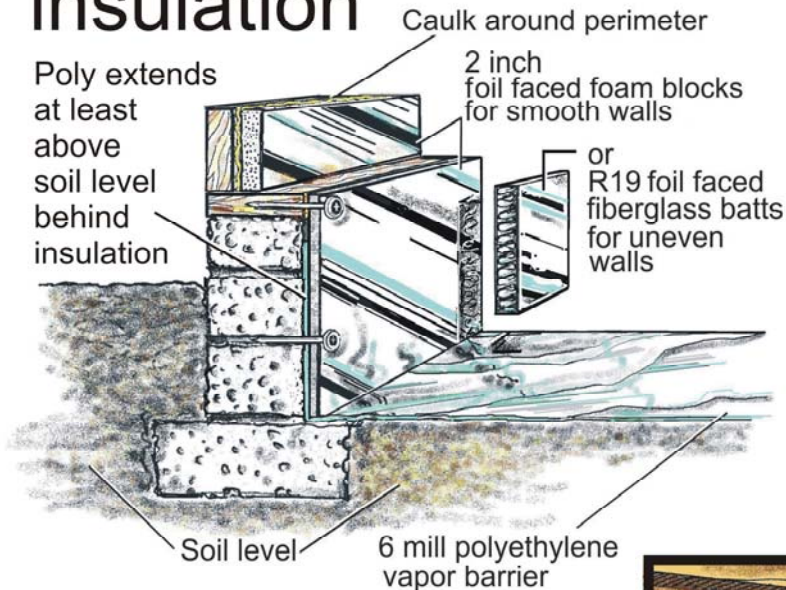
**Treatment:** the basic treatment is to cover the soil surface with 6 mil polyethylene plastic sheeting, carrying it at least above soil level around the exterior walls and sealing all seams so moisture vapor is trapped beneath the plastic sheeting.
