Cuyahoga County Urban Mold & Moisture Project

Housing Remediation

Jim LaRue
Environmental Health Watch
www.ehw.org

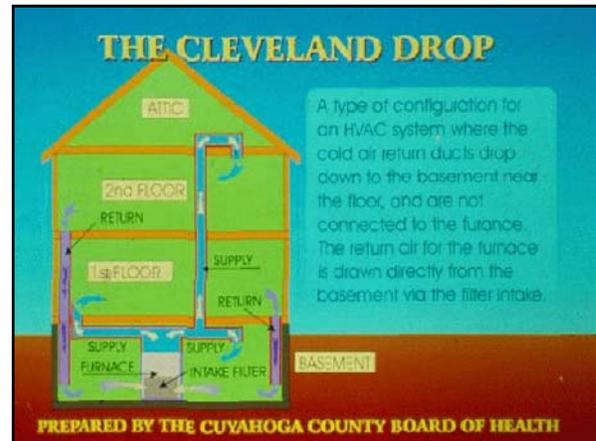
- Done a third of the houses; avg. cost = \$553; max \$1600
- Some contractors "panned" the floor joists with sheet metal instead of installing full duct

Repair of "Cleveland drop" by ducting cold air return directly to furnace

- 🏠 Cold air return not connected to forced air furnace
- 🏠 Furnace pulls air from across basement floor
- 🏠 Spec: Duct cold air return directly to furnace
